# Installed in next to no time

New urinal systems from Geberit

**The urinal systems at a congress hotel are showing their age and need a lot of maintenance. As a result, they are to be replaced by new ones without having to renovate the entire sanitary facility. The urinal systems from Geberit are perfect for such situations.**

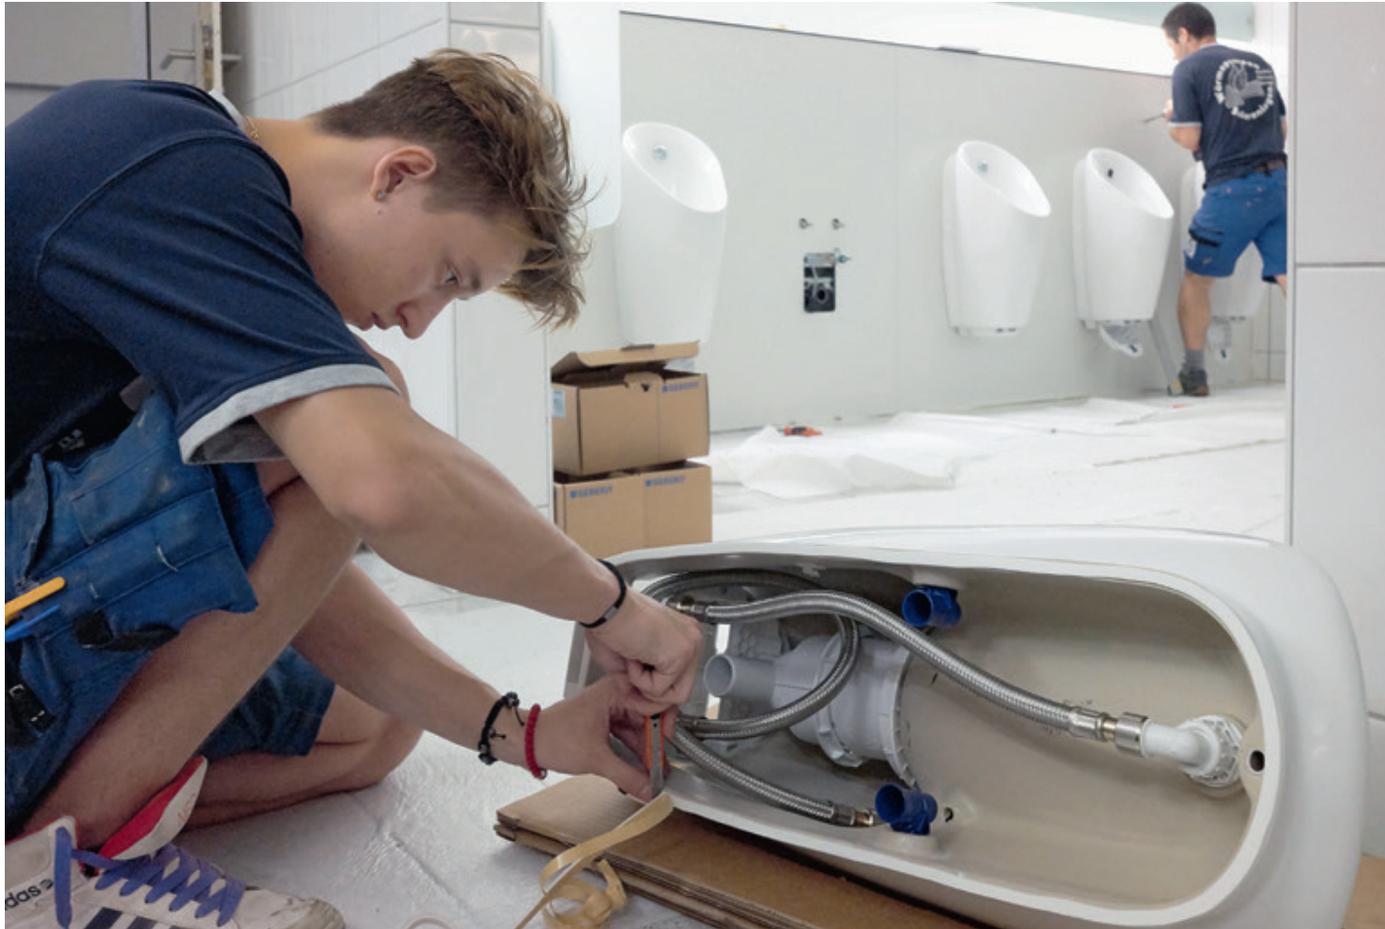
← Yannick Ramseier, an apprentice at Bürge Haustechnik AG, prepares a Geberit Preda urinal for installation. Head fitter Paul Arnold can be seen in the background installing urinal divisions.

On day four, the sanitary professionals were already able to set about installing the new urinals and divisions – a first for the two pros. “When installing the first urinal, we simply stuck to the installation manual,” said Paul Arnold, head fitter at the company Bürge Haustechnik. “The other five appliances and the divisions were then installed in no time – when it comes to installation, the new urinal systems from Geberit are well thought out right down to the last detail.”

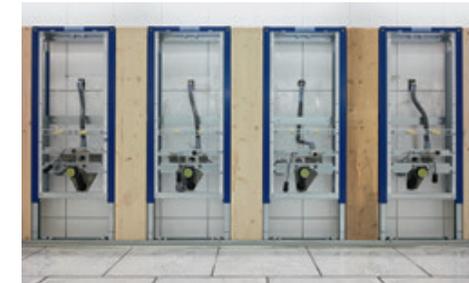
↑ The Duofix installation elements can be connected to the existing connections for water, electricity and waste water without the need for major adjustments.

Immediately after the old urinals had been removed, a specialist company professionally cleaned the discharge pipes behind the wall. It turned out that – despite having urine scale deposits here and there – the 30-plus-year-old Geberit PE pipes were otherwise in pristine condition. This enabled the plumbers to tackle the installation of the Geberit Duofix installation elements for the new urinals slightly ahead of schedule. This proved an easy task for the two sanitary professionals. Within just a few hours, the six blue metal frames were firmly secured to the wall and floor, all the connections for the new urinals were prepared and the wooden mounting plates for the urinal divisions were screwed on. The ensemble now constituted a perfectly aligned, robust supporting structure.

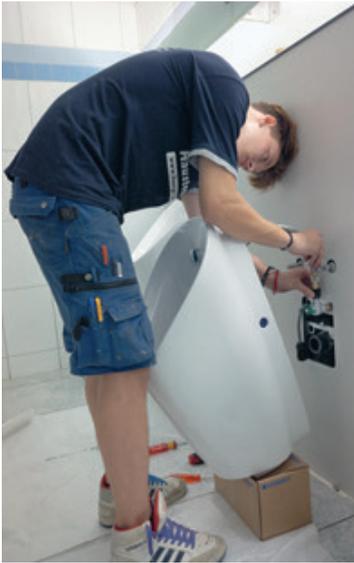
↑ Because the reinforced braided hoses have been specially prepared at the factory, connecting a Geberit urinal to the water supply is taken care of in next to no time.

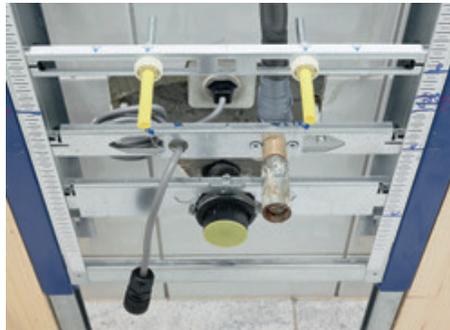
↑ The Geberit Duofix installation elements for urinal systems are prepared for the installation of the models Preda and Selva.

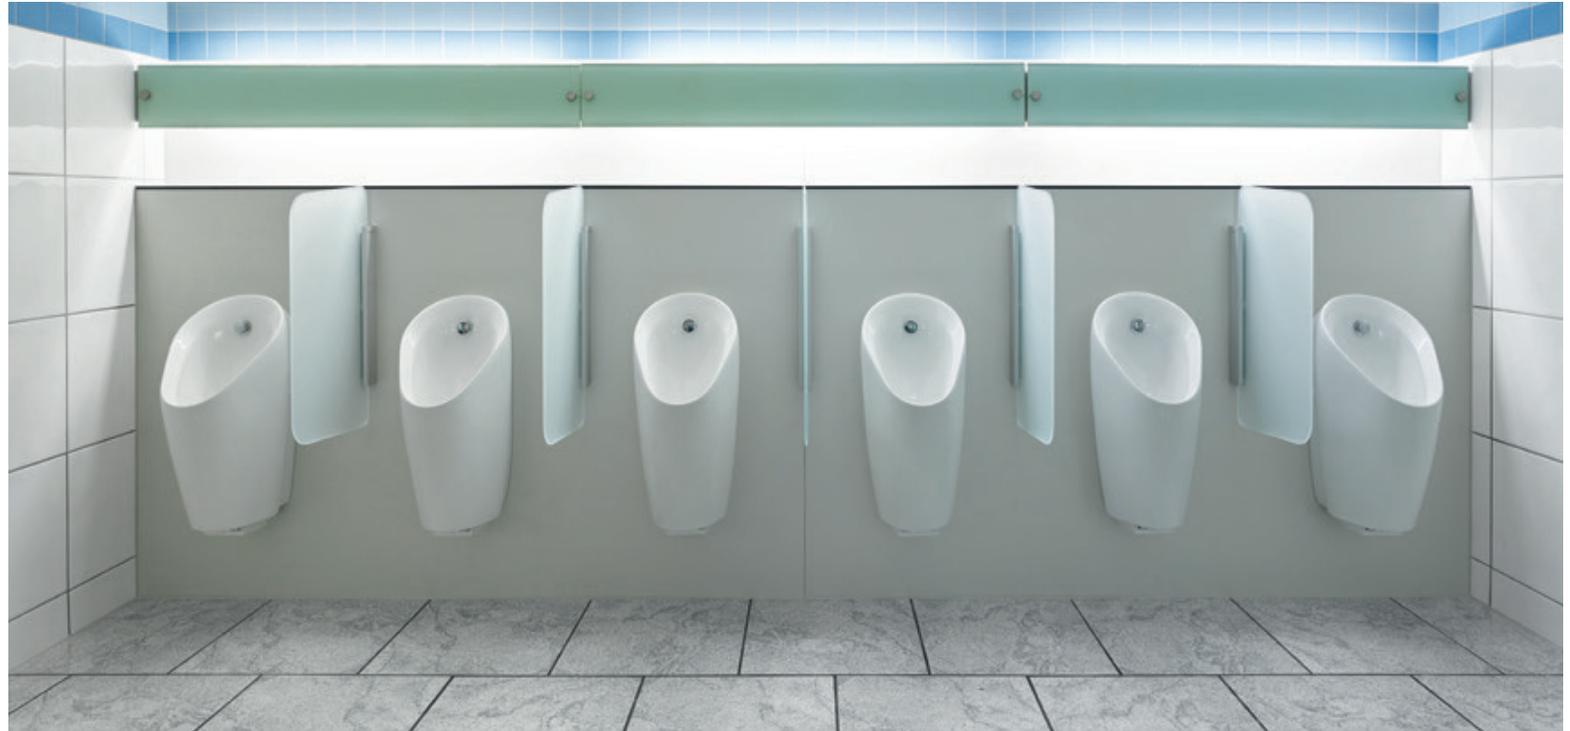
↑ After: The partial renovation of this toilet facility sees six new Geberit Preda urinals and Geberit urinal divisions installed in just four days.

Instead of panelling this structure with plasterboard and then cladding it with tiles, the hotel management opted to use a robust laminate for the cladding. No sooner were the plumbers finished installing the installation elements than two carpenters were ready to take measurements. Later that day in their workshop, they cut the sanitary wall's cladding, which comprises just four parts, to size with great precision before installing it the next day.

Marcel Sorrentino, head of facility management at the Mövenpick congress hotel, was delighted that the renovation work was completed after just four days. “I have great hopes regarding the design of these new urinal systems,” he says. “If something should not work, you can simply remove the entire control unit from the docking station and replace it with a replacement module. This is an elegant way of preventing interruptions in service.” ←

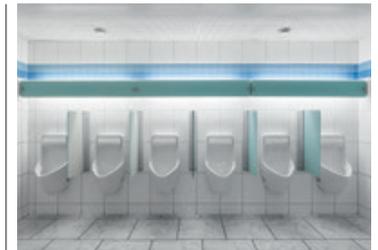
↑ Before: These old urinals have become prone to faults and are causing a lot of maintenance work.

Whenever possible, maintenance work is only carried out at the Mövenpick congress hotel close to Zurich Airport when there are no seminars and events for a few weeks. This was also the case with the partial renovation of a toilet facility, where six urinals with obsolete flush controls had to be replaced by new, maintenance-friendly systems. The wall tiles, floor tiles and all other installations were to remain in place here. The time frame for this project: five days.
